RESERVE STUDY

Regency Pines II Condominium Association, Inc.

Rockledge, Florida
March 9, 2022

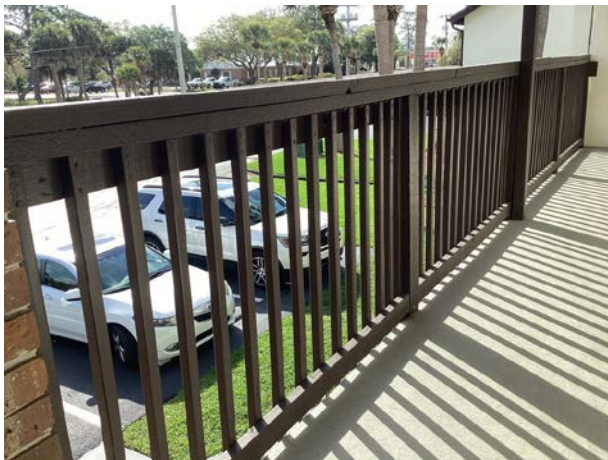
Conditions: The railings are in good to fair overall condition. We note areas of rot and exposed fasteners.

Balcony railings

Useful Life: Railings of this type have a useful life of 20- to 25-years with the benefit of periodic maintenance. Periodic maintenance should include applications of a protective paint finish and partial replacement of deteriorated wood every six- to eight-years.

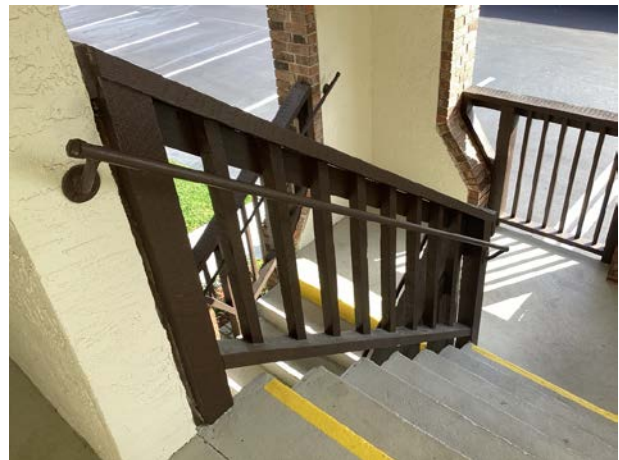
Wood railing at staircase

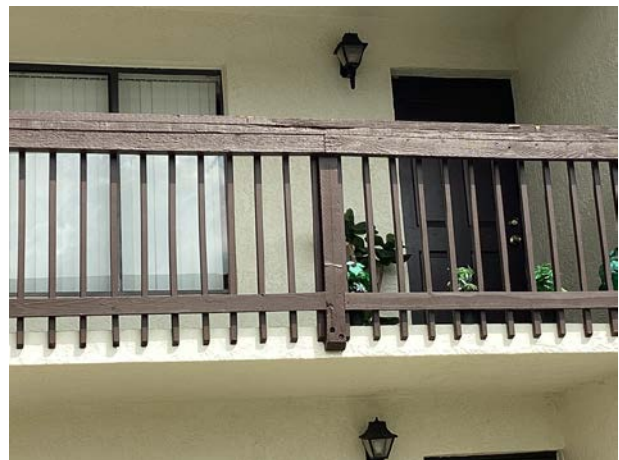
Damage at balcony railing

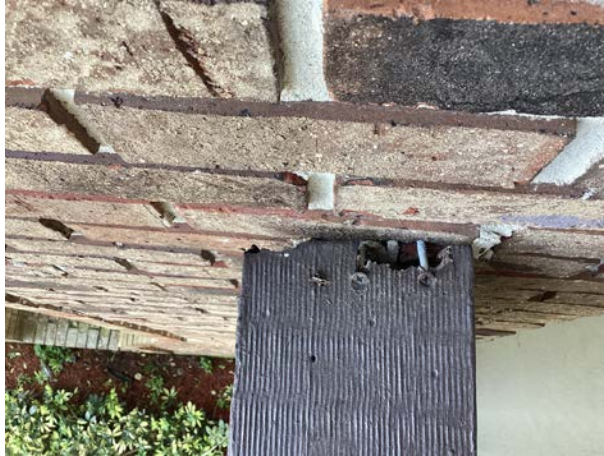
Wood rot at balcony railing

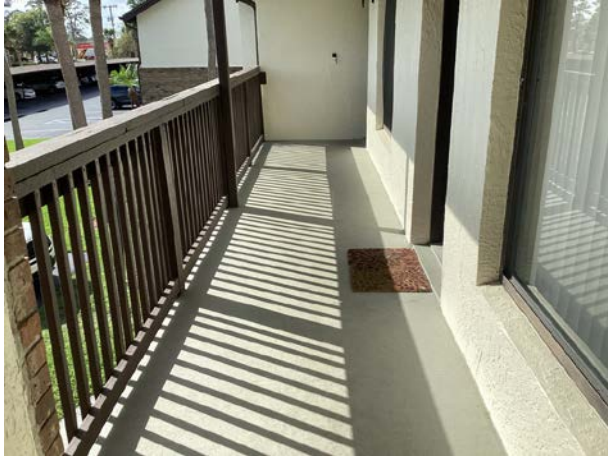
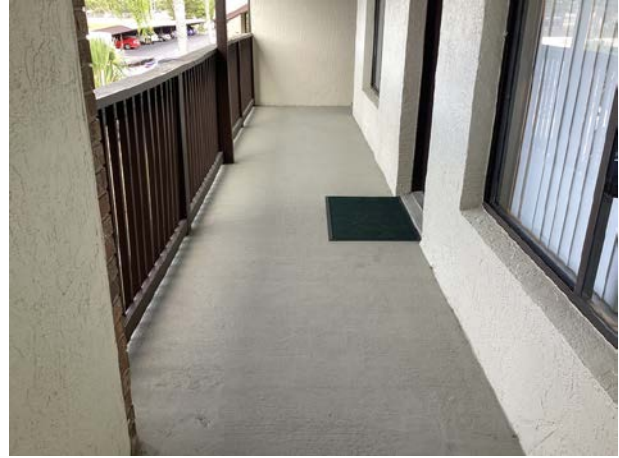
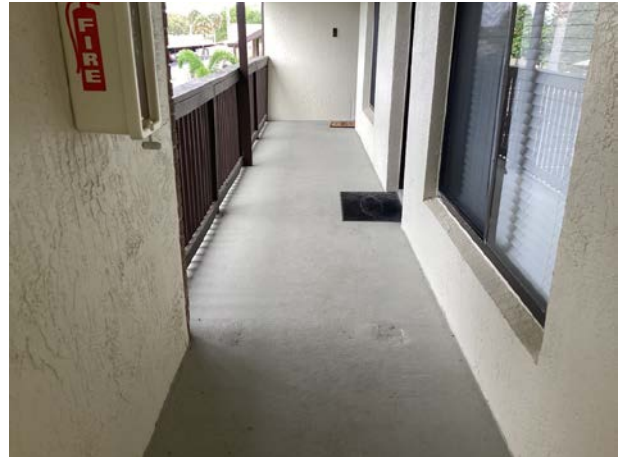
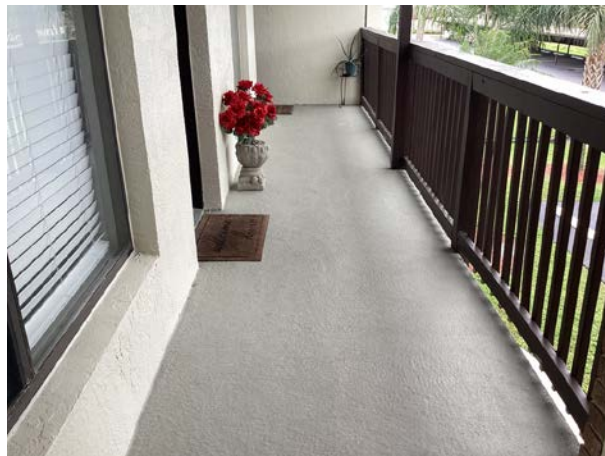
Condition: Good to fair overall

Balcony overview

Balcony surface

Useful Life: Capital repairs including a close-up visual inspection, patching of delaminated concrete, routing and filling of cracked concrete, and waterproof coating applications every 8- to 12-years.

- Partial depth replacement of up to one percent (1%) of the concrete topsides, edges and undersides
- Crack repairs as necessary
- Repairs to the railings as necessary
- Replacement of perimeter sealants as needed
- Application of a waterproof coating (Urethane based elastomeric)

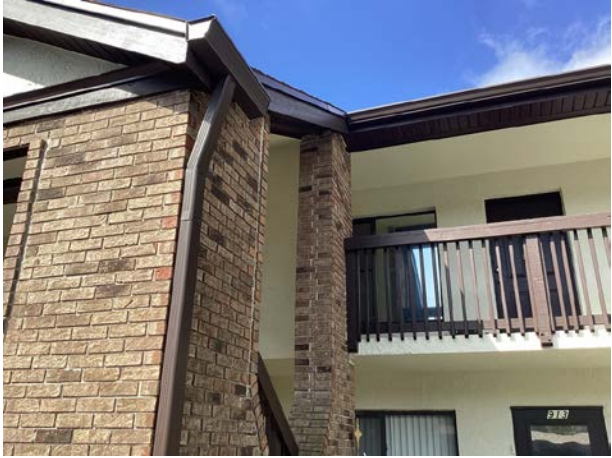
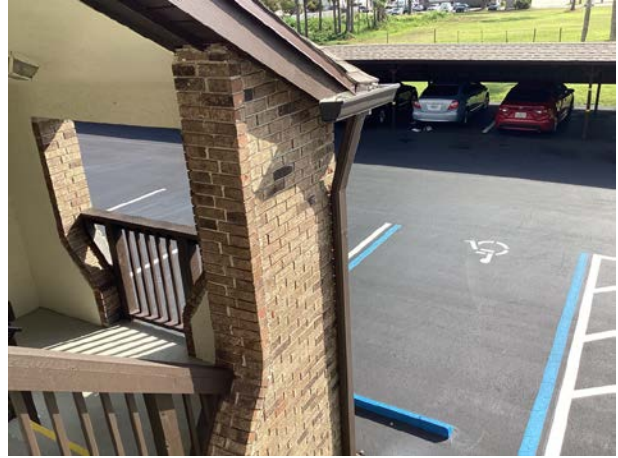
Condition: Good overall with isolated dents evident.

Aluminum gutters and downspouts

Gutter and downspout

Component Detail Notes: The size of the gutter is determined by the roof's watershed area, a roof pitch factor and the rainfall intensity number of the Association's region. We recommend sloping gutters 1/16 inch per linear foot and providing fasteners a maximum of every three feet.

Downspouts can drain 100 square feet of roof area per one square inch of downspout cross sectional area. We recommend the use of downspout extensions and splash blocks at the downspout discharge to direct storm water away from the foundations.

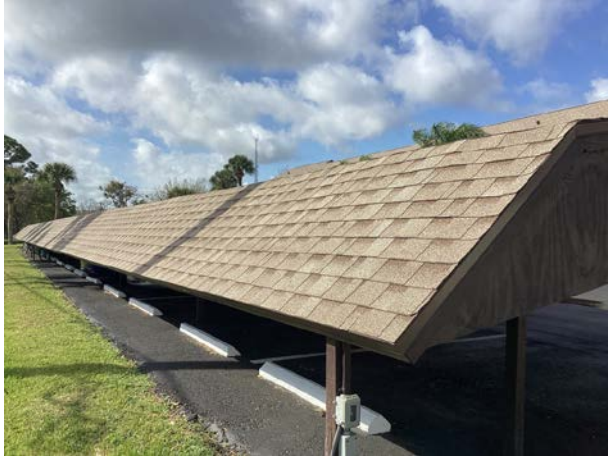
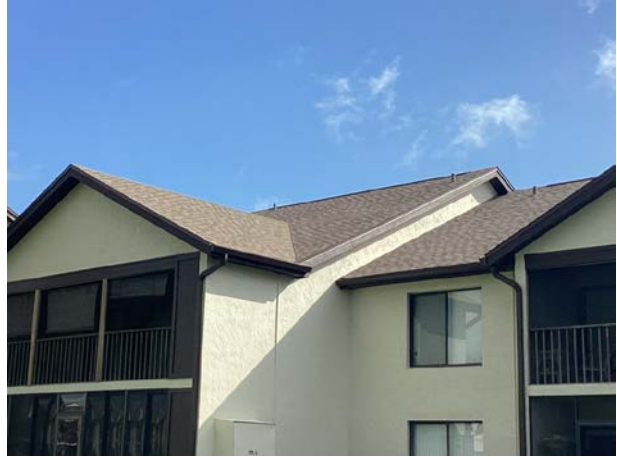
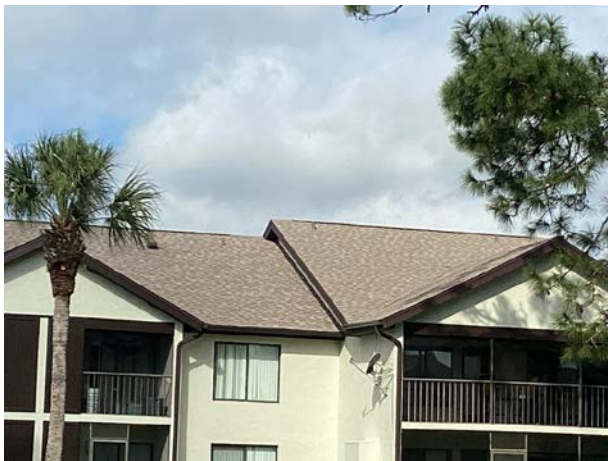
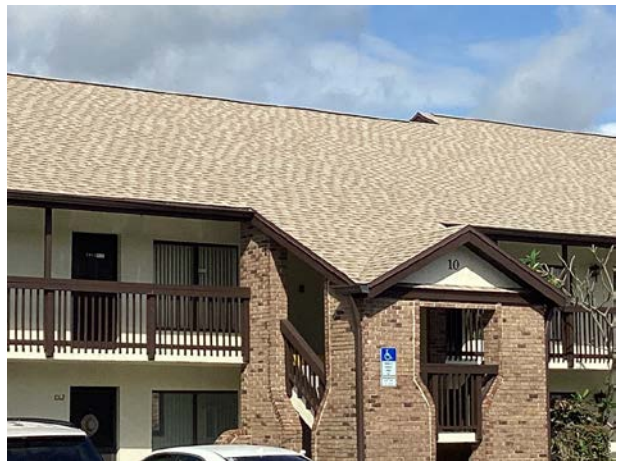
Condition: Good overall with no significant deterioration evident from our visual inspection from the ground. The Board does not report a history of leaks.

Carport roof

Valley detail

Roof overview

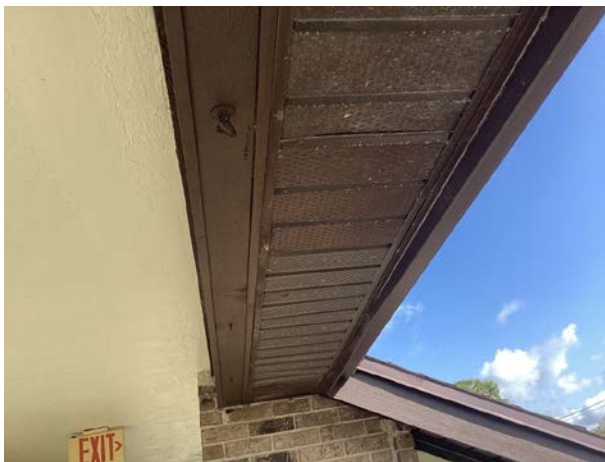
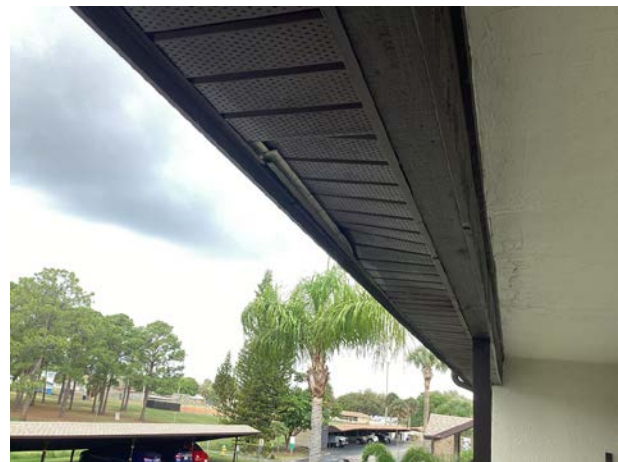
Condition: Fair overall

Aluminum soffit

Aluminum soffits and fascia damage

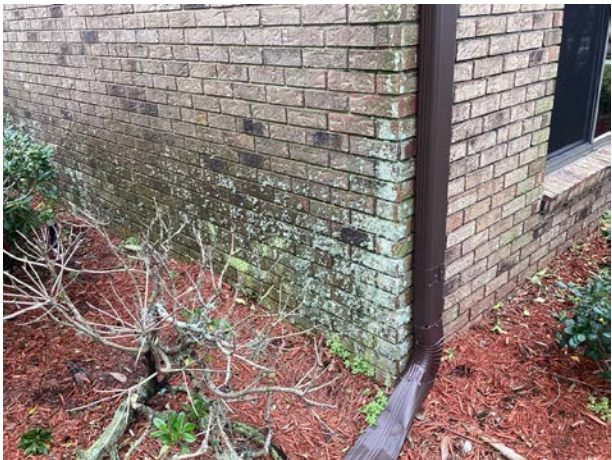
- Reported history of water infiltration. Repairs were conducted to remediate the issues.
- Efflorescence is not visible
- Lintels exhibit rust jacking (cracks in the masonry due to rusting and expanding of the lintel steel)
- Masonry exhibits isolated cracks
- No spalled masonry is evident
- Minor mortar deterioration is evident

Biological growth at masonry wall

Useful Life: We advise a complete inspection of the masonry and related masonry repairs 8- to 12-years to forestall deterioration.

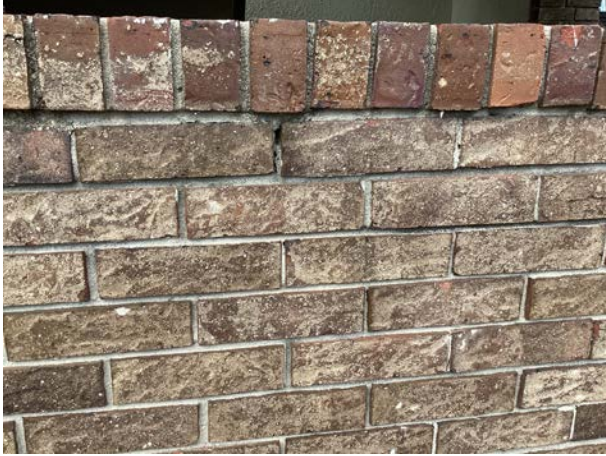
Isolated mortar deterioration

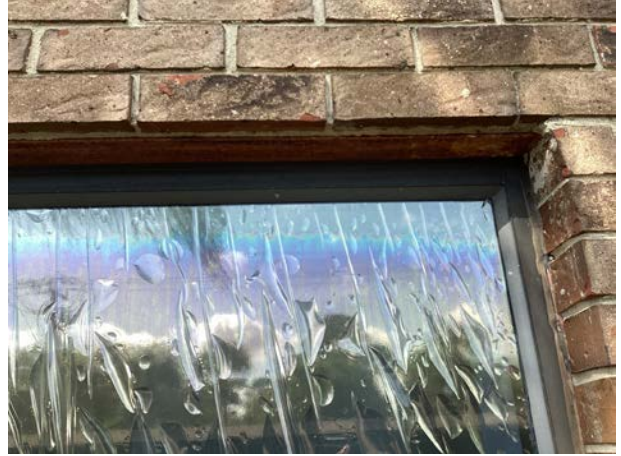
Lintel rust

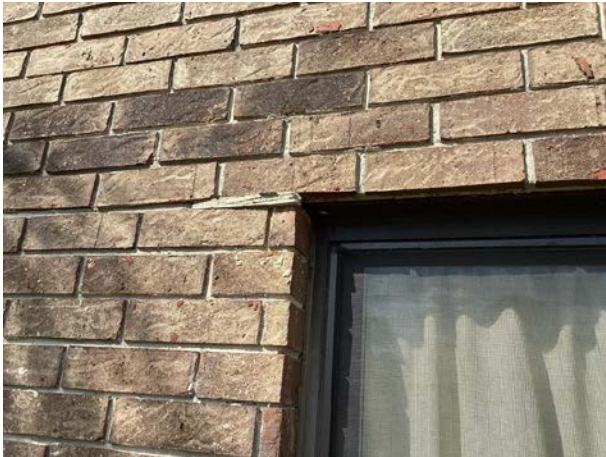
Mortar deterioration at lintel

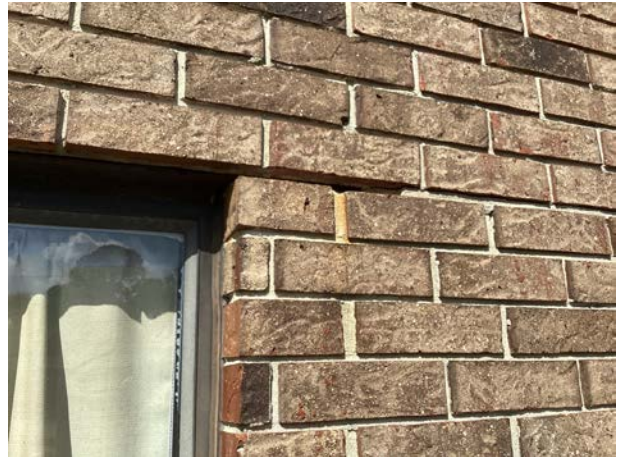
Missing mortar due to rust at lintel

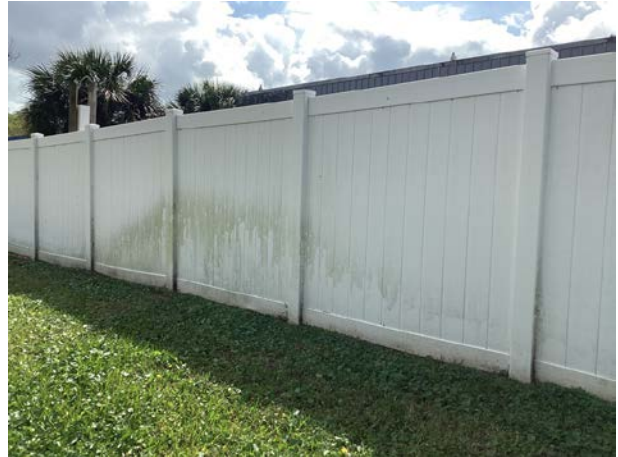
Condition: Good to fair overall

Biological growth at vinyl fence

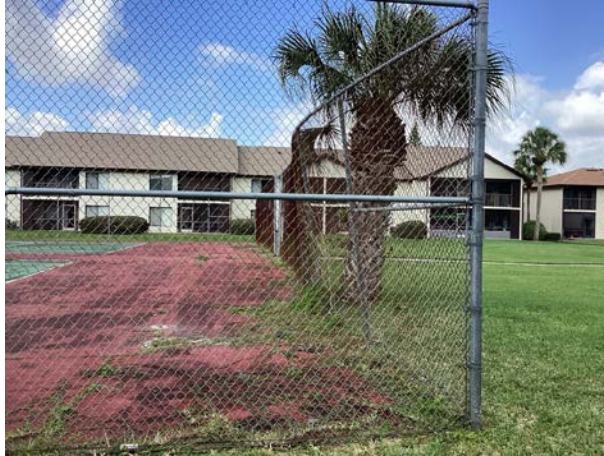
Condition: Fair to poor overall. The Association informs us it has been decided to remove the tennis courts and fence in the near future.

Chain link fence lean

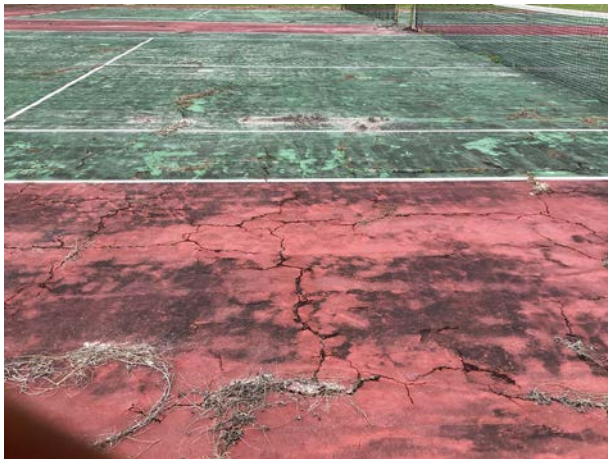
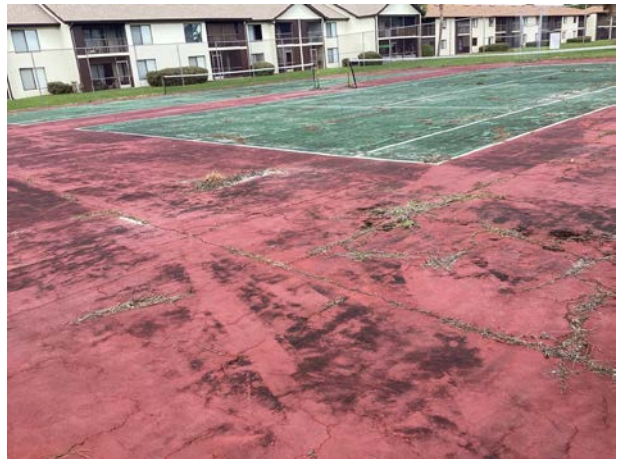
Condition: Poor overall. The Association informs us it has been decided to remove the tennis courts in the near future.

Tennis court surface

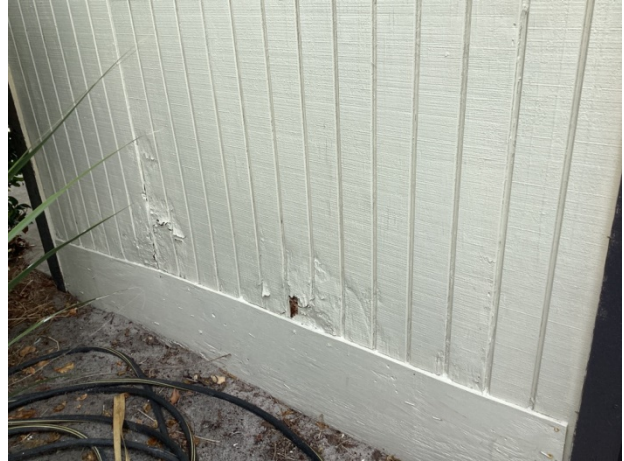
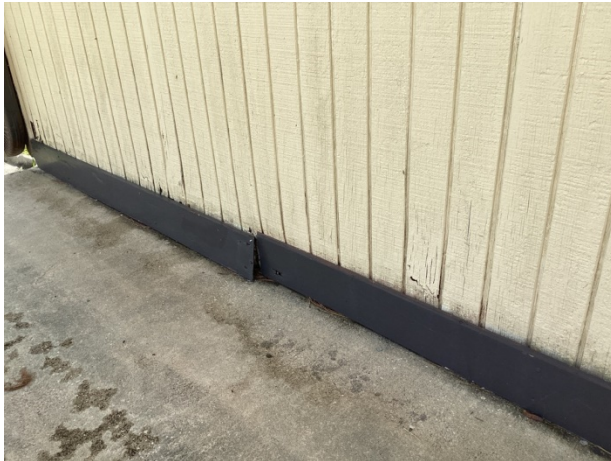
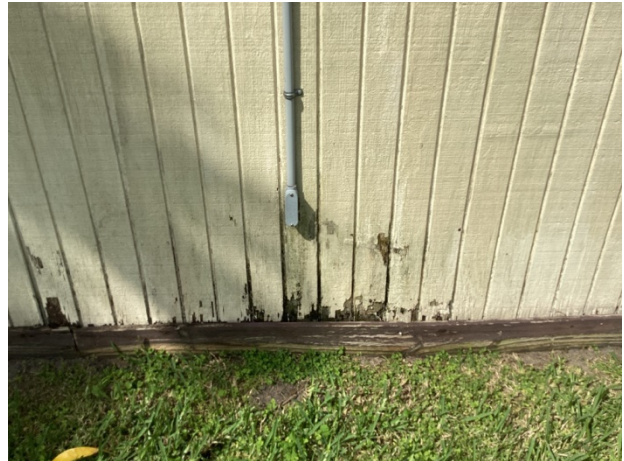
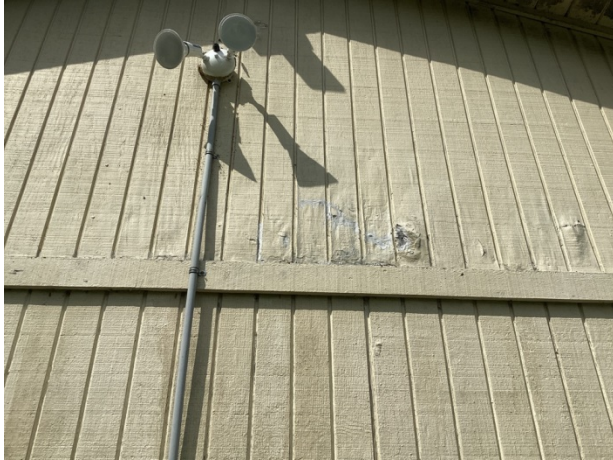
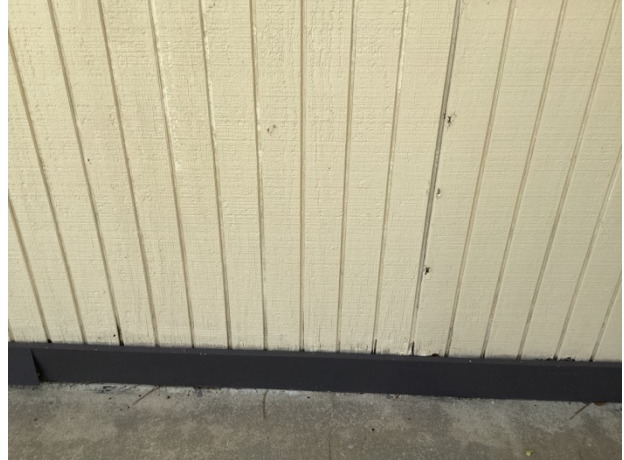
Condition: Fair to poor overall

Wood rot at pool house

Useful Life: Up to 35 years. This useful life is dependent upon timely paint applications and partial replacements of deteriorated siding.

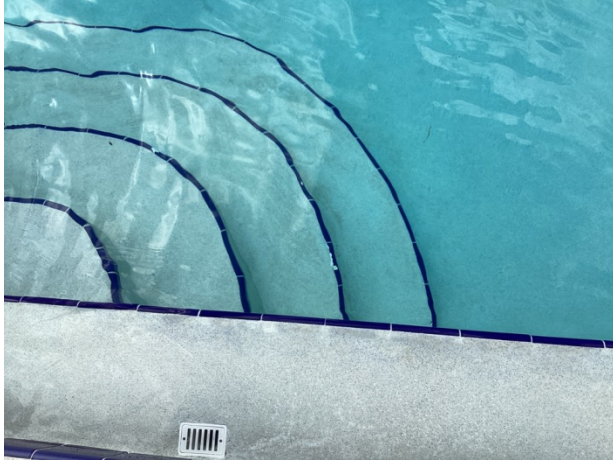
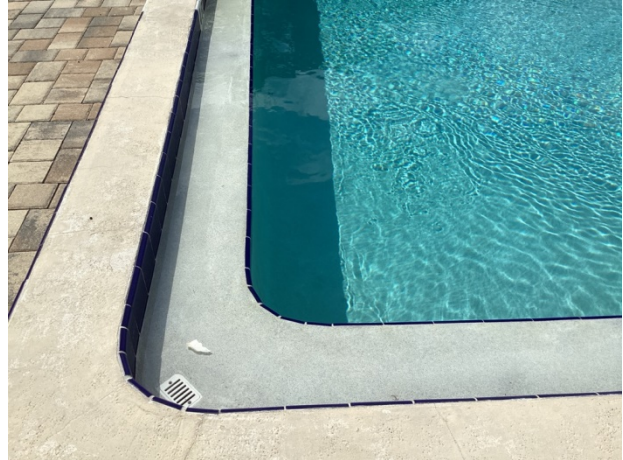
Condition: Fair overall. We note areas of chipped plaster.

Plaster pool finish

Useful Life: 8- to 12-years for replacement of the plaster finish and tile repairs
